November 28, 2025

Our file: 18196-2507

Re: 76 West Avenue North, Hamilton – Structural Condition Assessment

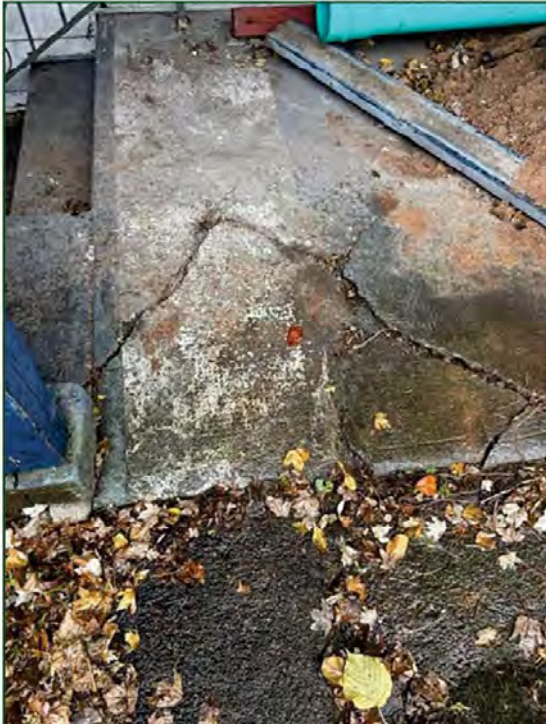
- Evidence of moisture/water ingress was throughout the structure,
- Cracking observed in the front entrance slab (Photo 1),
- Recently replaced sanitary line at front yard (Photo 2),
- Undersized/deteriorated structure at front deck (Photo 3),
- Collapsed block wall at front entrance basement walkout (Photo 4)

Photo 1 – Slab At Front Entrance

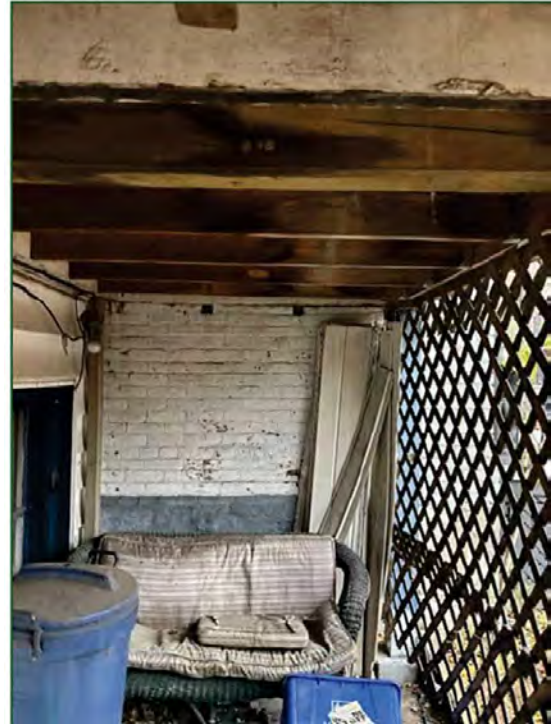
Photo 3 – Second Floor Front Deck Framing

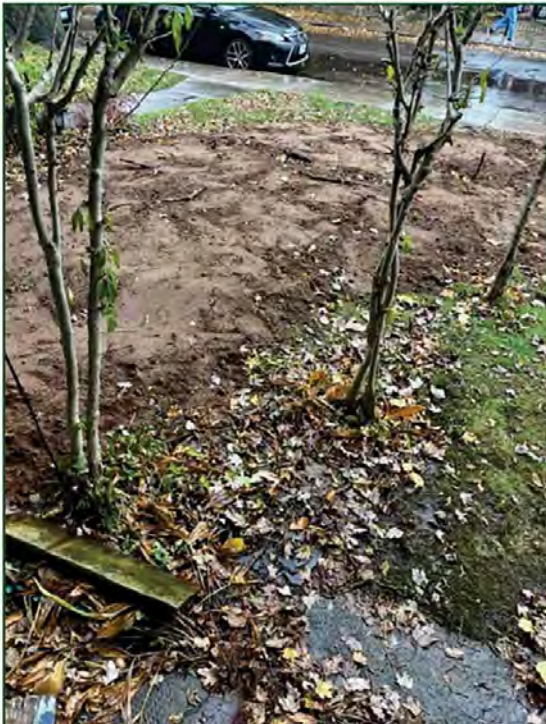
Photo 2 – Front Yard

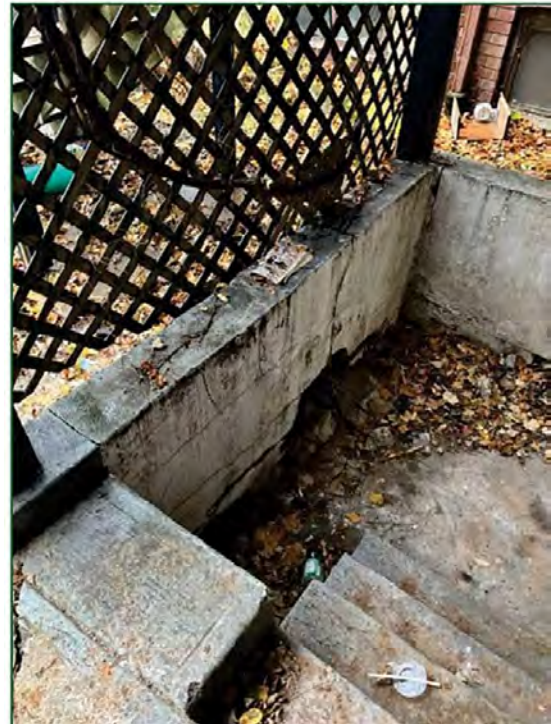
Photo 4 – Collapsed Walkout Wall

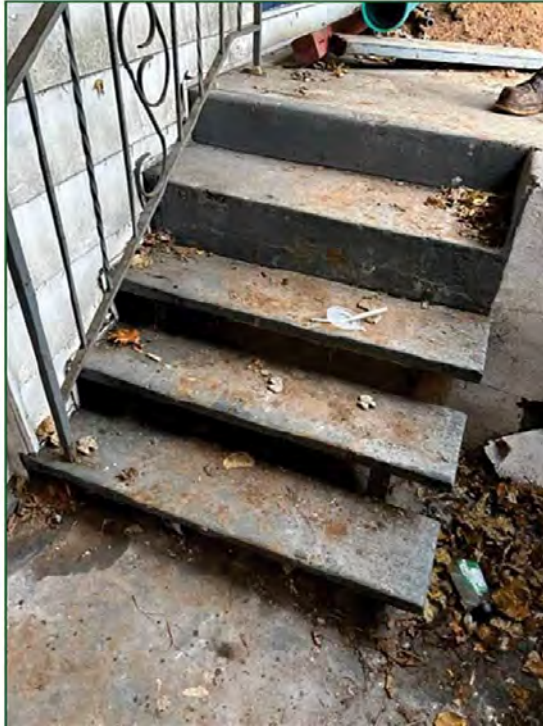
- Non-code compliant and compromised stair at basement walkout (Photo 5)
- Spoils of excavation stockpiled in the basement (Photo 6),
- Compromised wood floor structure bearing directly on soils below at basement floor. Open sanitary line with pooling of sanitary discharge (Photo 7 & 8),

Photo 5 – Front Entrance Basement Stairs

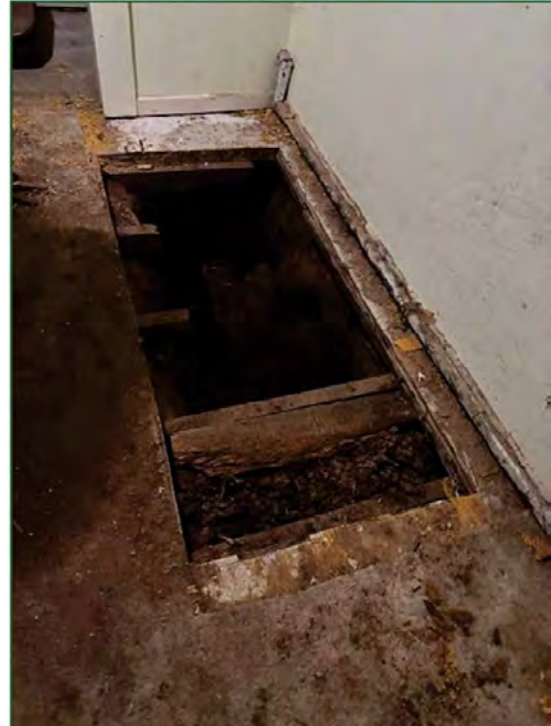
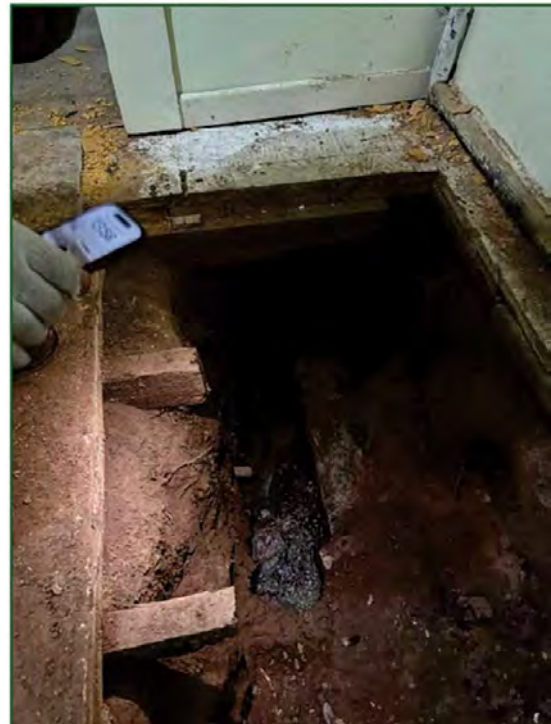
Photo 7 – Compromised Wood Floor with Open Sanitary Drain

Photo 8 – Compromised Wood Floor with Open Sanitary Drain

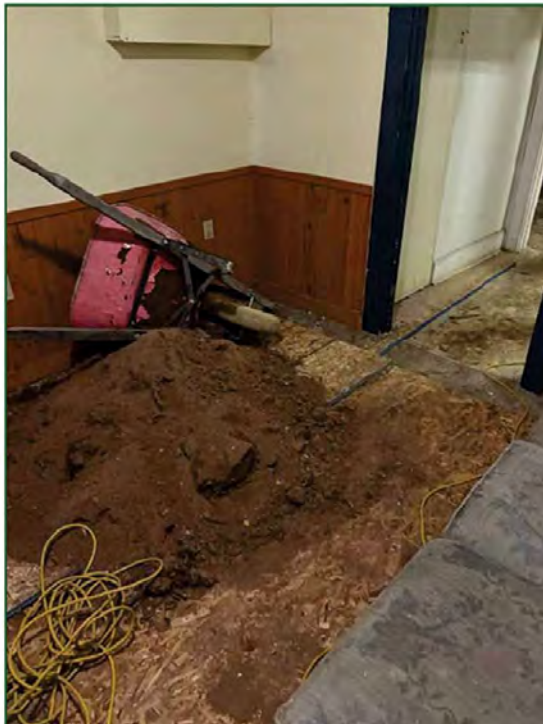
Photo 6 – Spoils From Basement Excavation

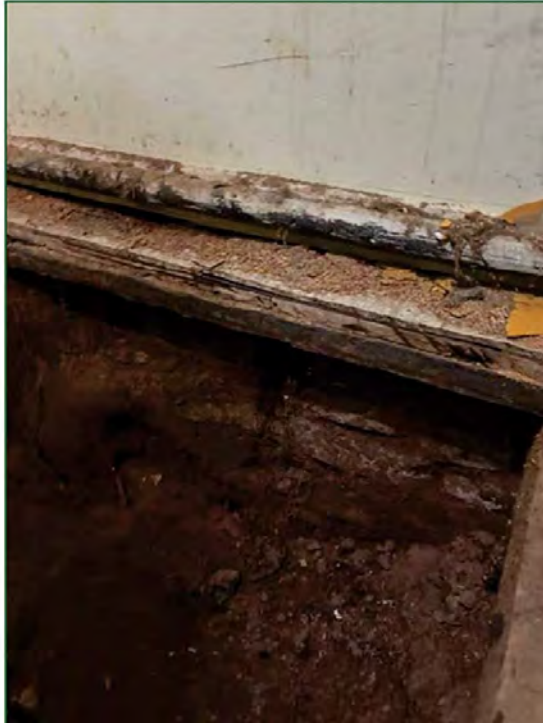
- Deterioration in foundation wall at south (Photo 9),
- Basement concrete slab at former bathroom (Photo 10 & 11),
- Typical floor joists with moisture staining / damage (Photo 12),

Photo 9 -Deteriorated Foundation Wall

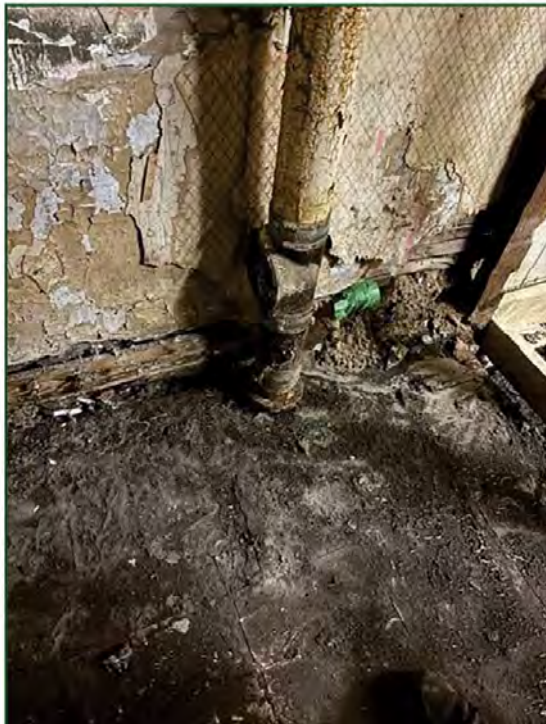
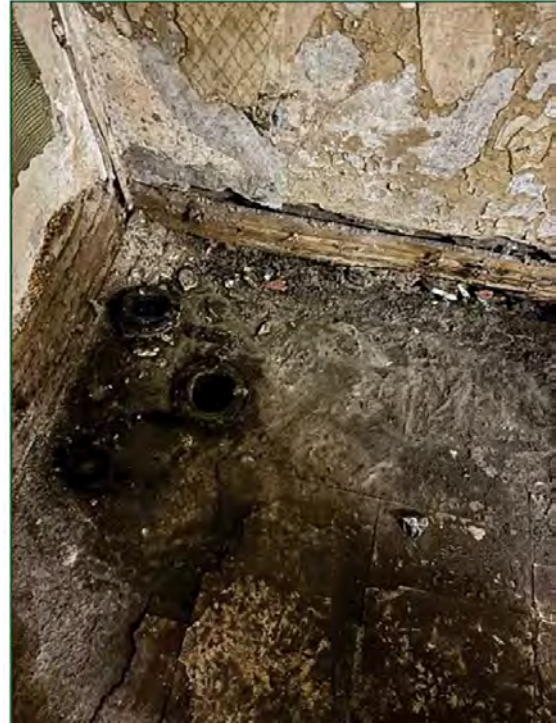
Photo 10

Photo 11 – Basement Slab

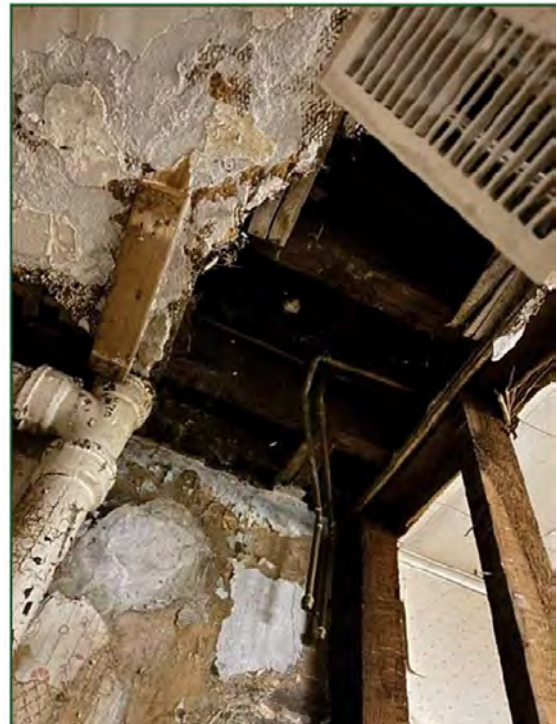
Photo 12 – Moisture Damaged Floor Joists

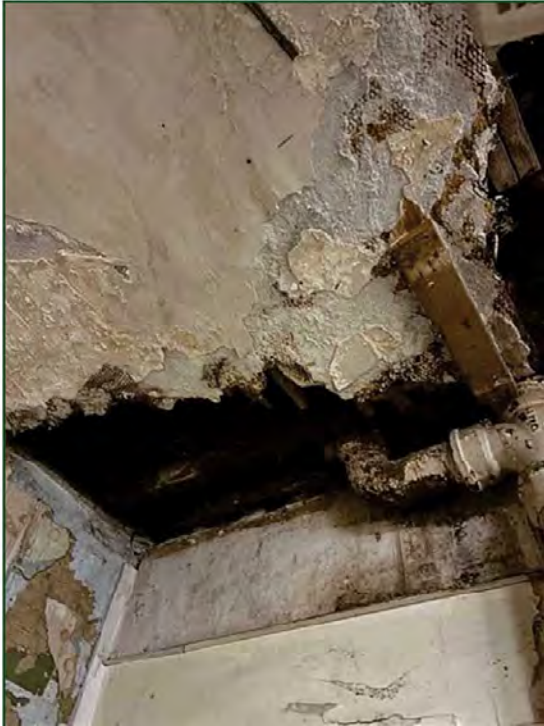
- Rotted floor joists above basement bathroom (Photo 13)
- Compromised load bearing studs in basement, rotted through (Photo 14)
- Infill wood basement floor framing with no isolation to soils below (Photo 15 – 17) complete with organics and vegetation growth,

Photo 13 – Moisture Damaged Floor Joists

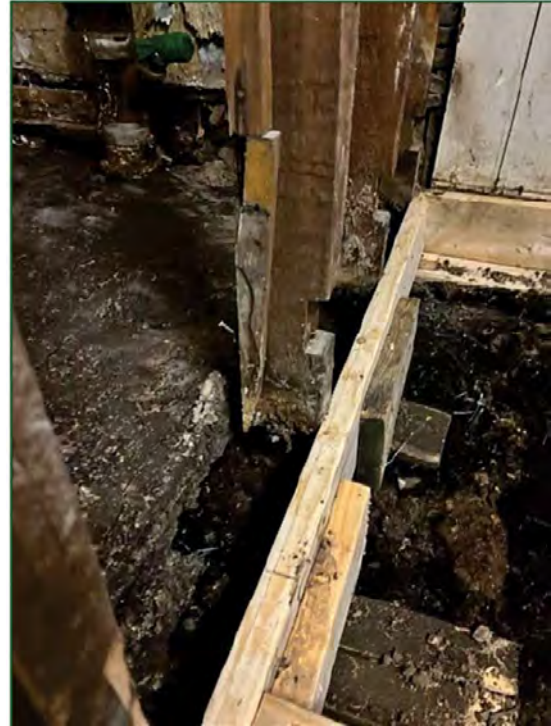
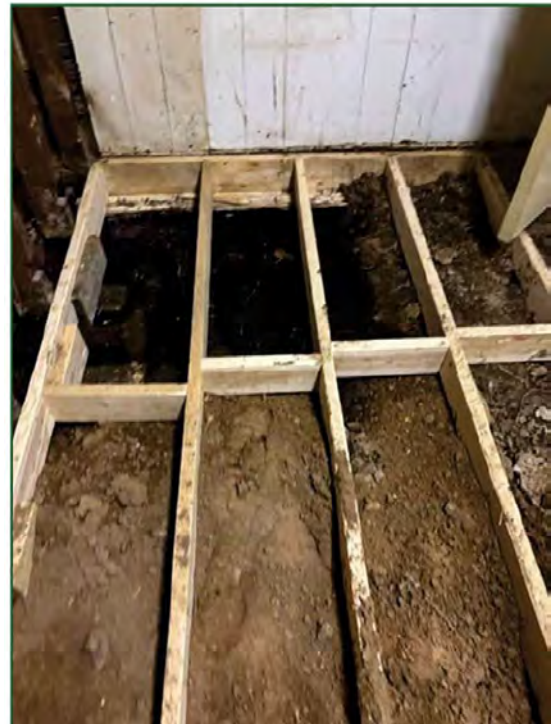
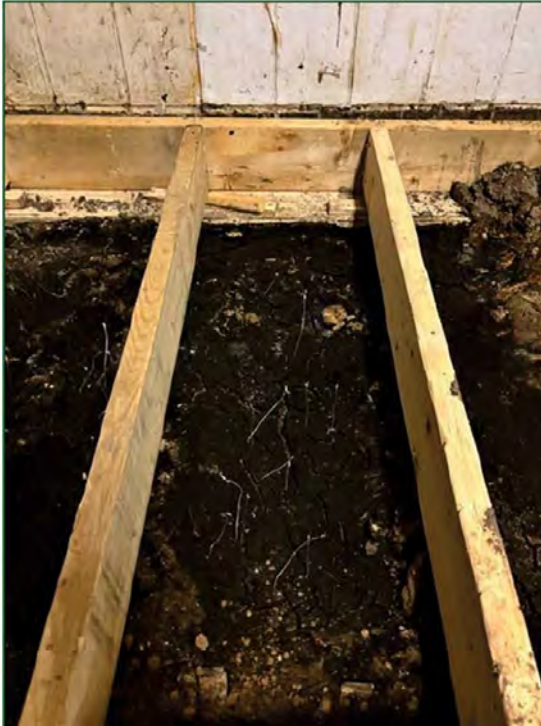
Photo 15

Photo 16 – Re-Framed Wood Floor on Soils with no Isolation

Photo 17 – Vegetation Growth at Floor Infill

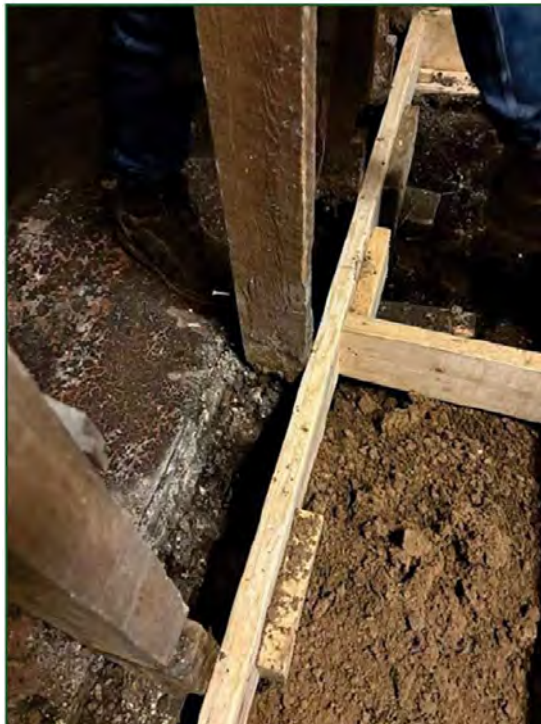
Photo 14 – Rotted Stud at Base of Load Bearing Wall

The load bearing wall in the basement was completely rotted at the base resulting in the floor structure over-spanning its capacity.

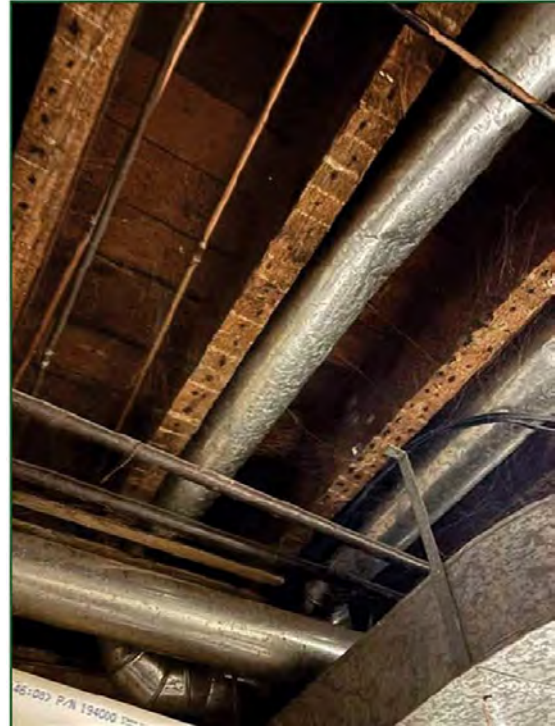
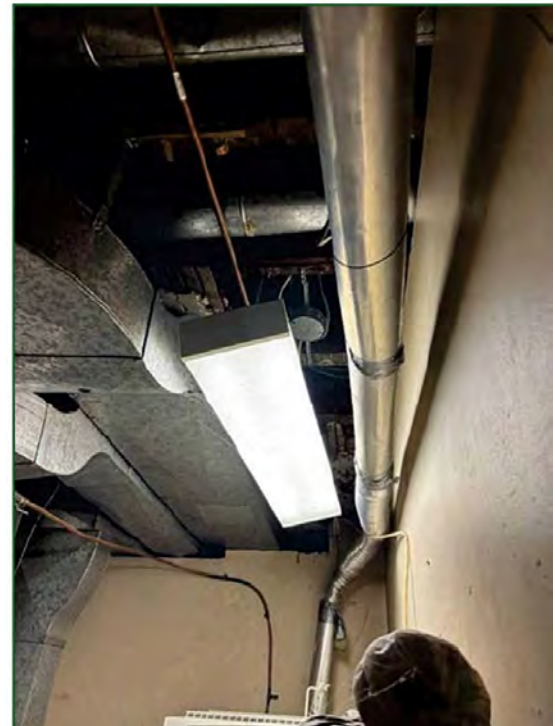
Photo 20

- Collapsing floor structure at mechanical room (Photo 18),
- Typical floor joists (Photo 19–20),
- Collapsing brick wall with make shift shoring at rear brick addition (Photo 21),

Photo 19 – Typical Floor Joists

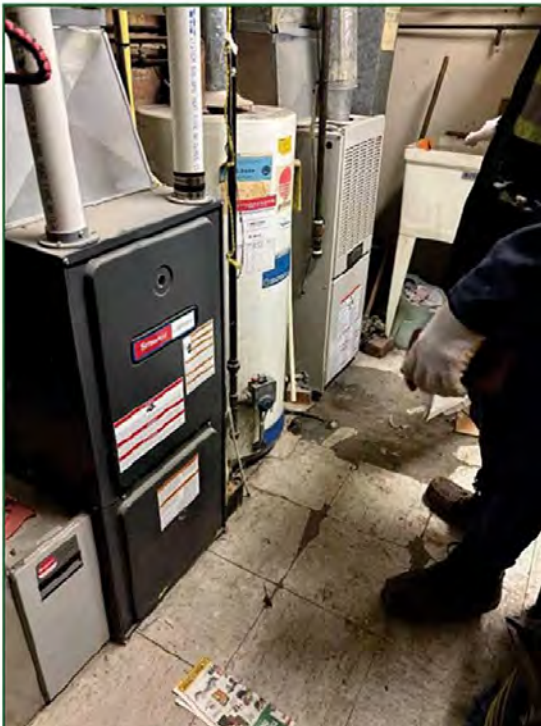
Photo 18 – Failing Floor at Mech Room

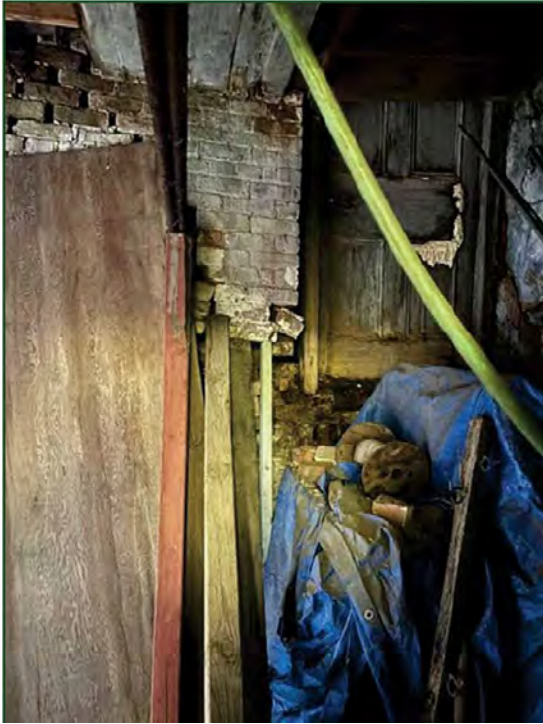
Photo 21 – Collapsing Brick Wall at Rear Entry

The poorly temporarily supported collapsing brick walls are the rear addition are in imminent danger of collapse, especially given the large opening in the roof permitting th elements to further deteriorate the area.

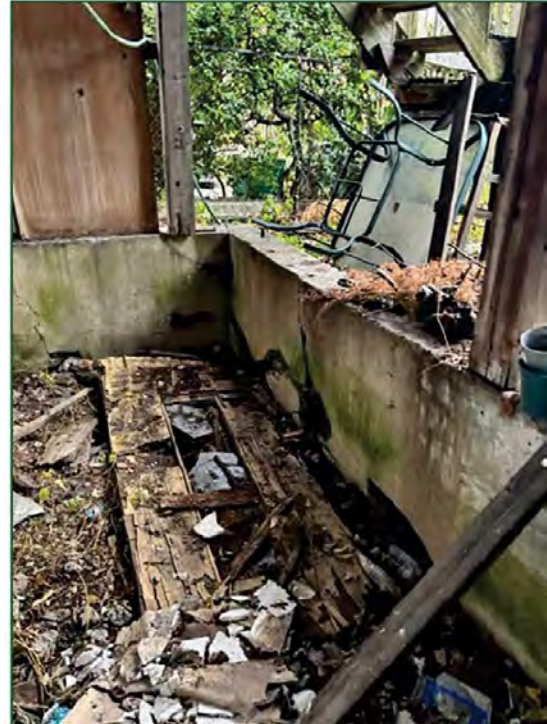
- Compromised/rotted rear deck framing (Photo 22 & 24)
- Collapsing concrete walkout wall at rear (Photo 23),
- Cracked/settling brick wall at rear addition (Photo 25–29),

Photo 23 – Collapsing Walkout Wall at Rear Entry

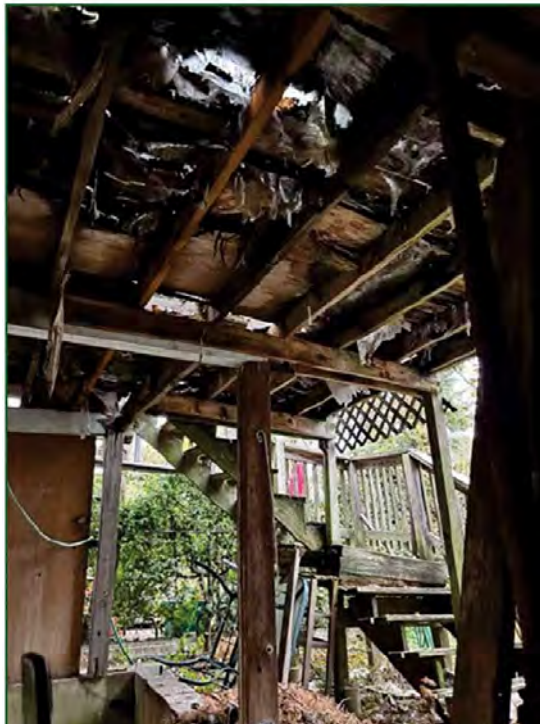
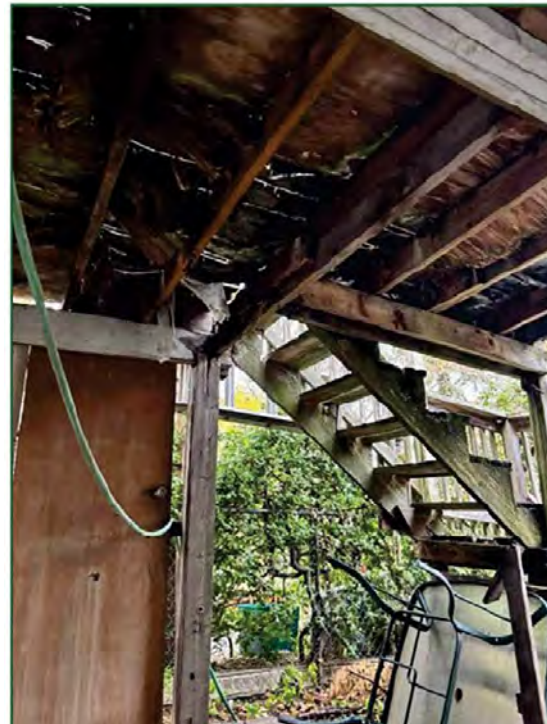
Photo 22 – Compromised/Rotted Deck Joists and Plank at Rear Entry

Photo 24 – Compromised/Rotted Deck Joists and Plank at Rear Entry

The rear deck is completely rotted and is not safe for use.

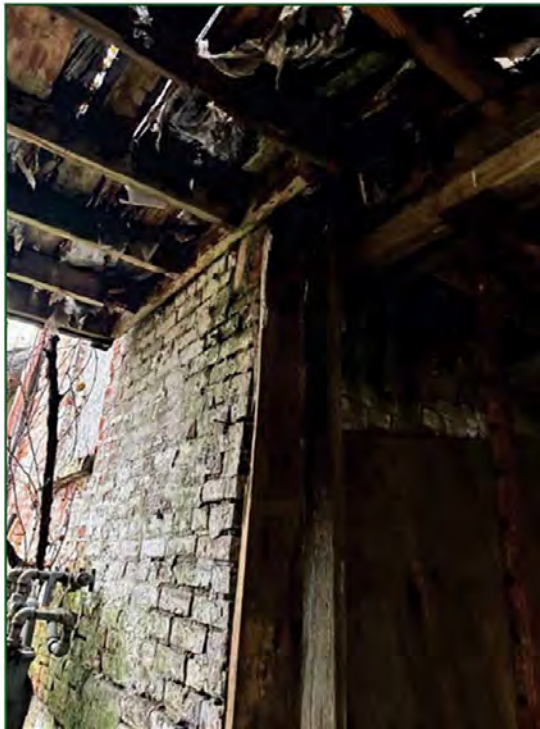
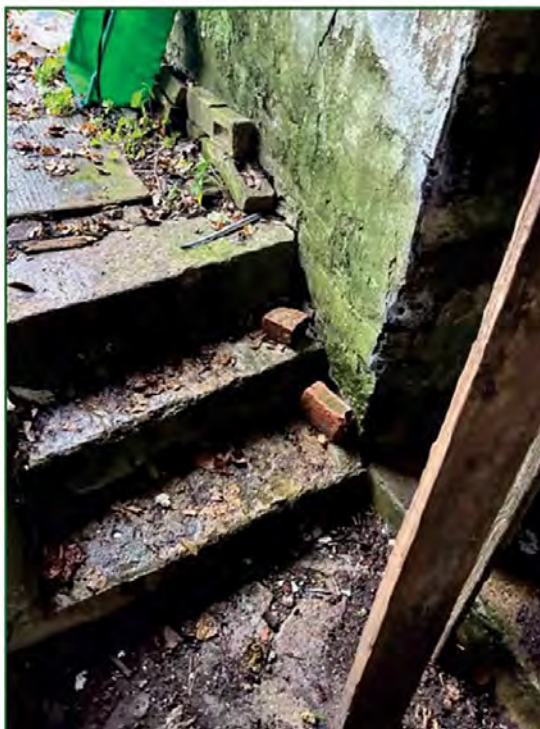
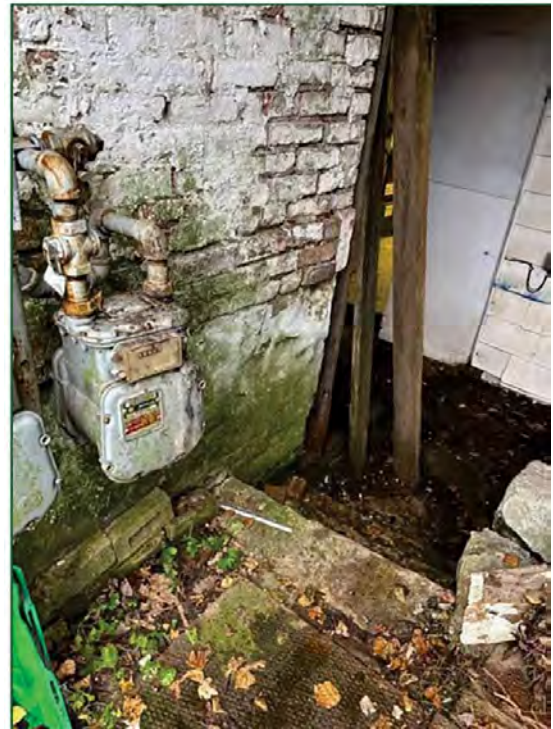
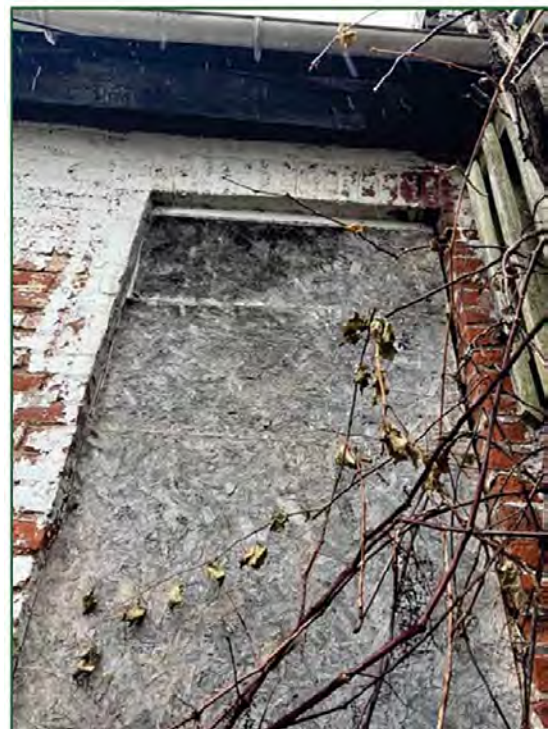
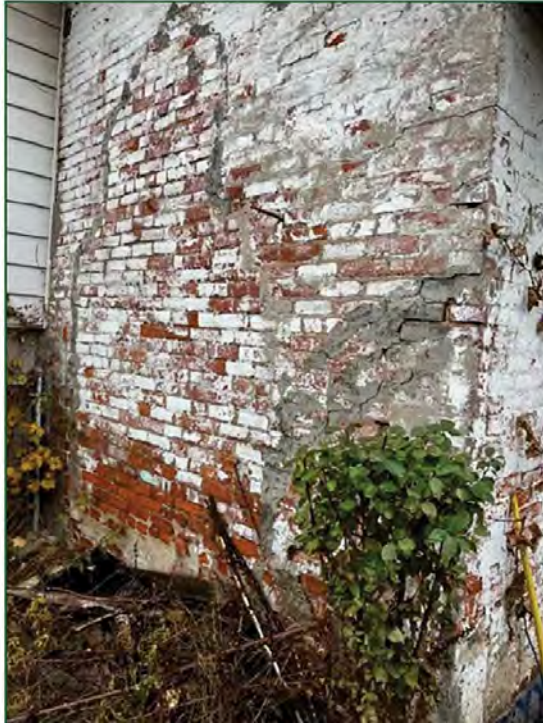
**Photo 25 – Cracked/Settling Brick Wall at
Rear Addition**

**Photo 27 – Cracked/Settling Brick Wall at
Rear Addition**

Photo 29 – Cracked/Settling Brick Wall at Rear Addition

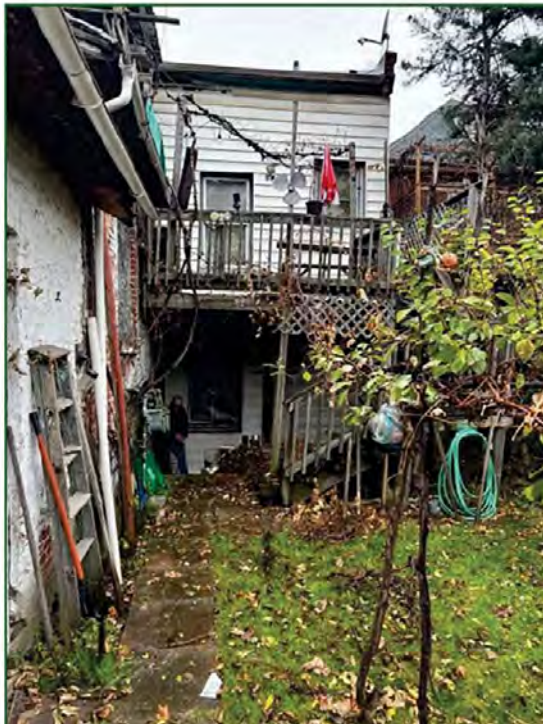
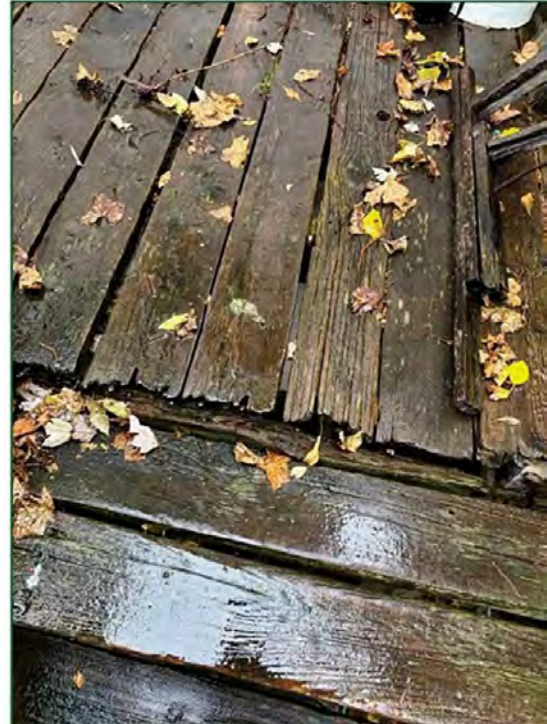
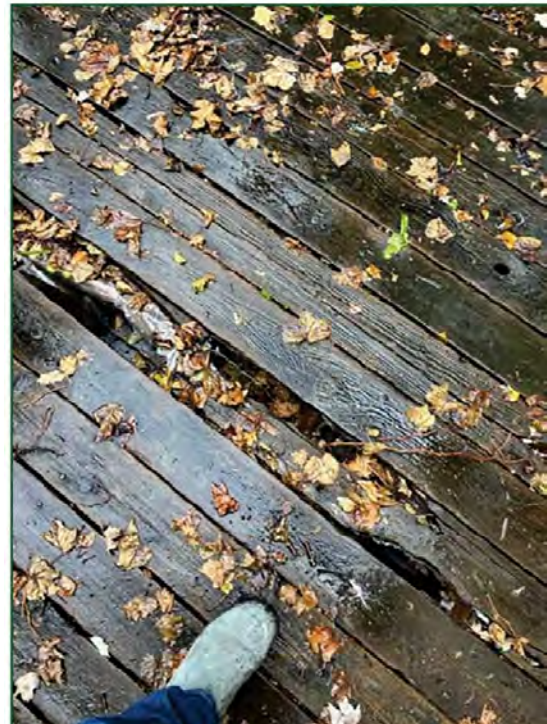
- Significant rotting of wood rear deck structure (Photo 30–32),
- Rotted roof structure at 3 season room at rear of building (Photo 34 & 36),
- Collapsing brick wall with make shift shoring at rear brick addition at second floor (Photo 37)

Photo 31 – Rotted Deck Boards at Rear Stair

Photo 32 – Rotted Deck at Rear Stair

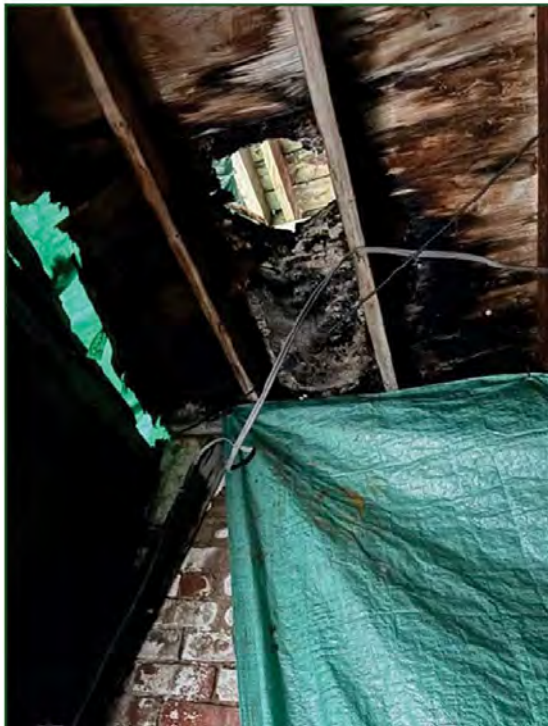
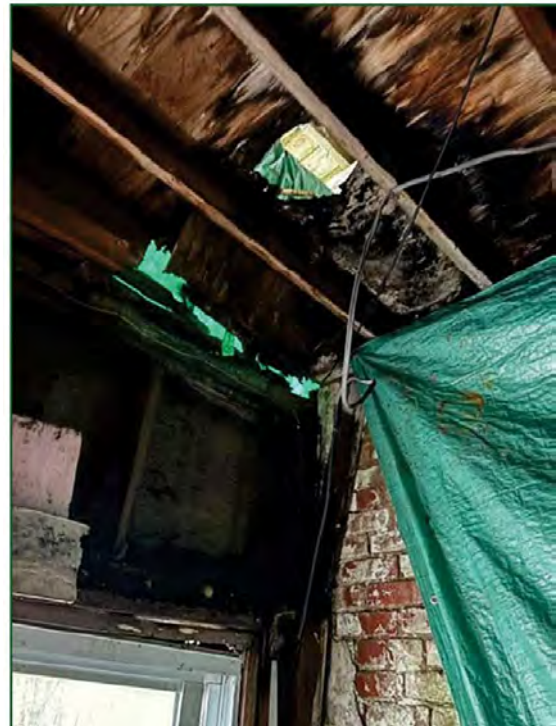
Photo 34 – Rotted Roof at 3 Season Room

Photo 36 – Rotted Roof at 3 Season Room

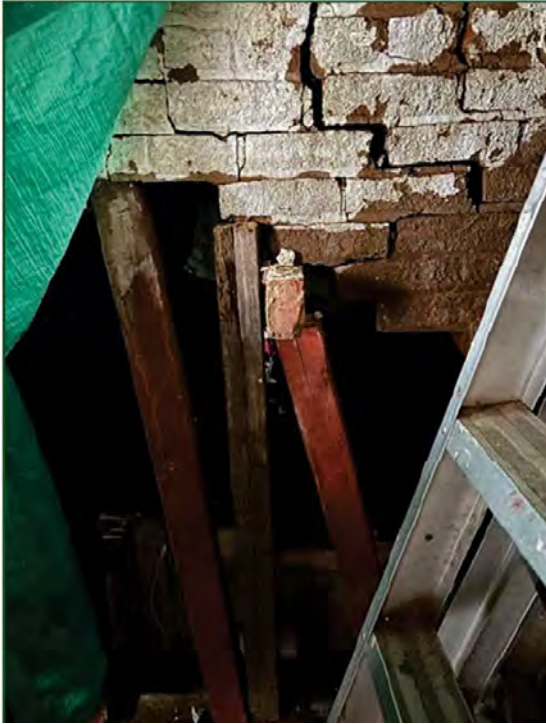
Photo 37 – Poorly Shored/Failing Opening in Brick Wall at Rear Addition

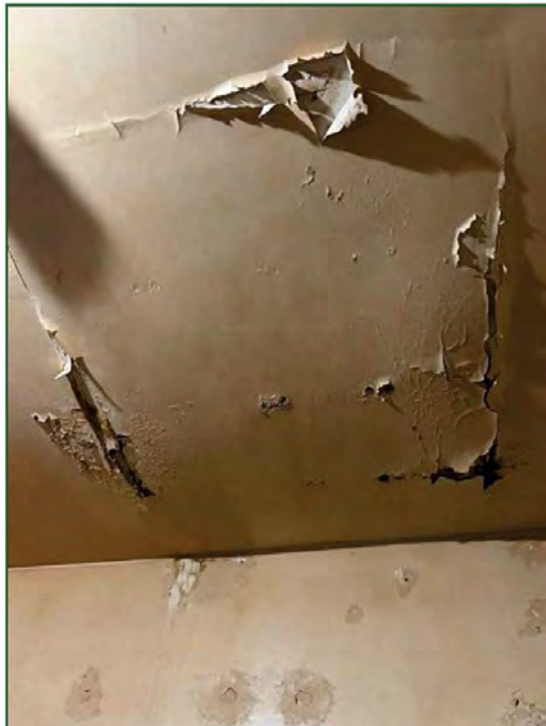
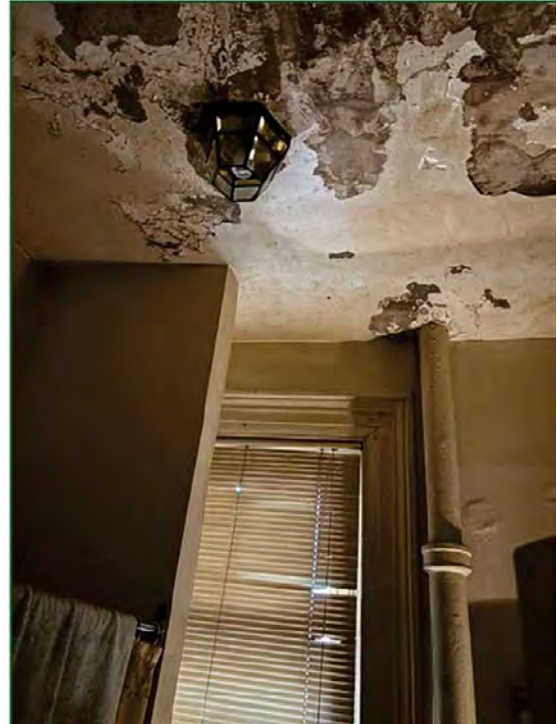
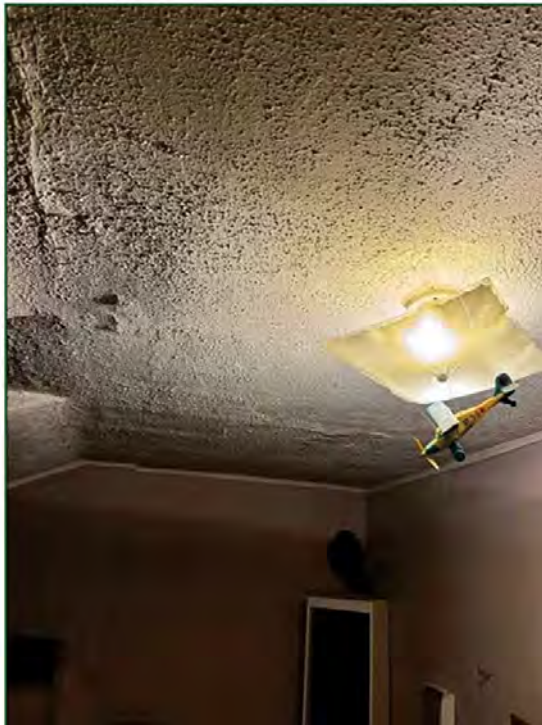
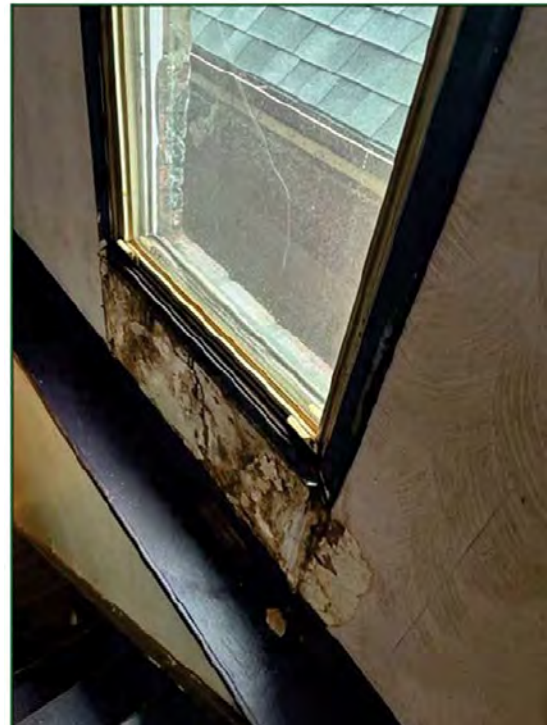
- Moisture throughout ceiling finishes (Photo 38, 39, 49 & 51),
- Significant sloping in main floor structure at corridor (Photo 40),
- Significant sloping in main floor structure at kitchen (Photo 44),

Photo 39 – Moisture Damage in Ceiling

Photo 38 – Moisture Damage in Ceiling

Photo 51 – Moisture Ingress

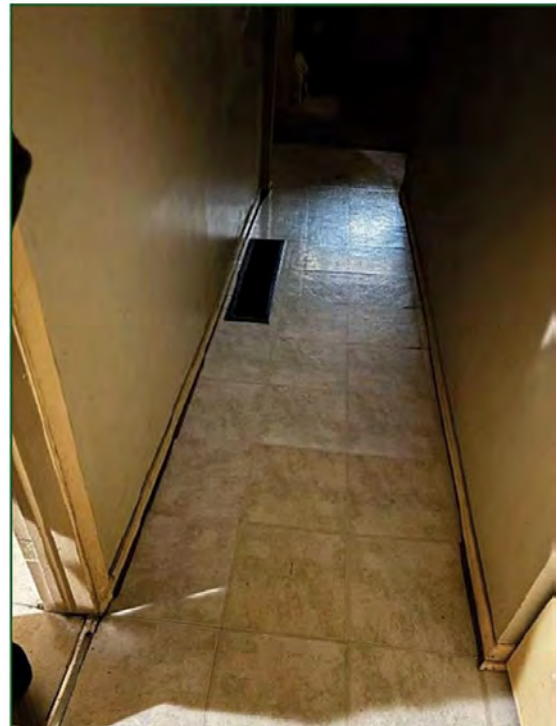
Photo 40 – Significant Sloping in Second Floor

Furthermore, the floor structure was sloping considerably and was deflecting a significant amount.

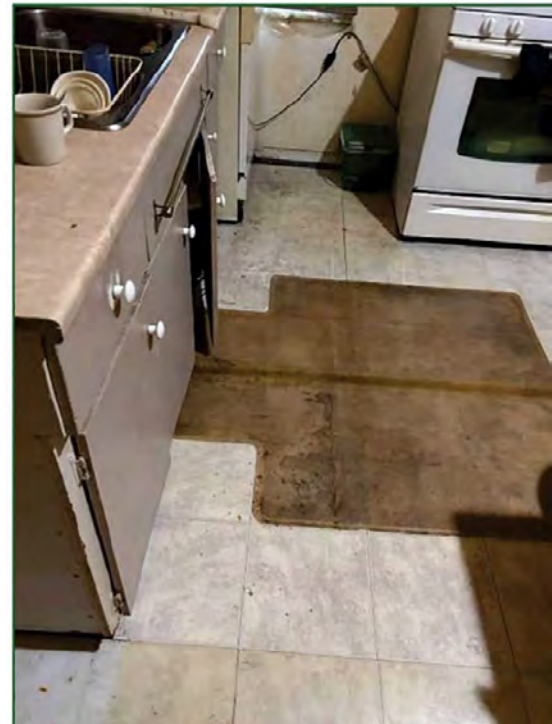
Photo 44 – Significant Sloping in Second Floor

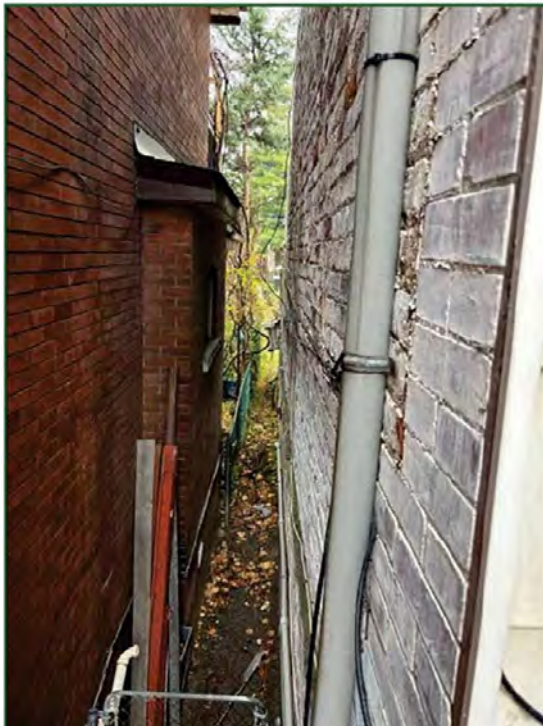
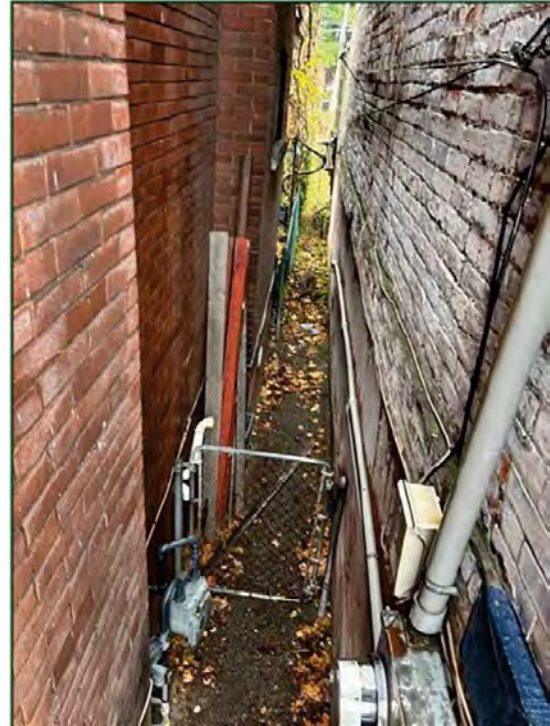
Photo 54

- Moisture evidence and poor drainage throughout the exterior walls with poorly configured/constructed eavestroughs and downspouts contributed to the water ingress (Photo 54 & 55),

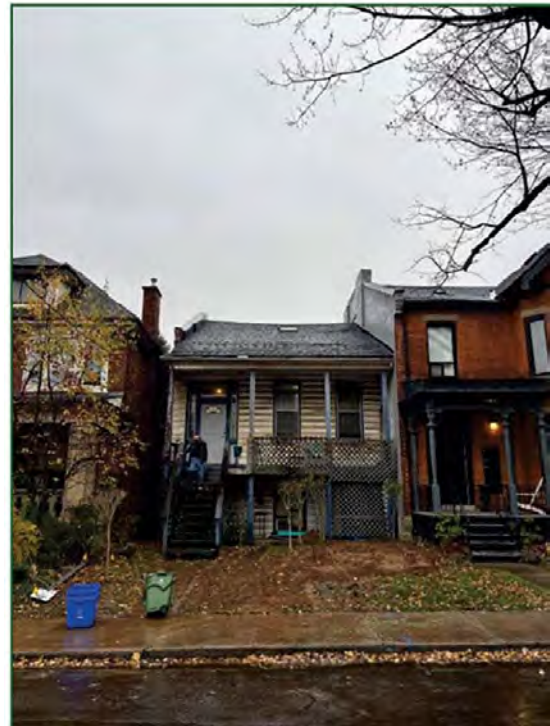
- Significant sagging/bowing of the front roof structure above the front deck (Photo 56),
- Deterioration of the parapets were observed,

Photo 56 – Significant Deflection in Front
Roof Structure

There is considerable bowing/deflection of the roof over the front porch area, as well as significant water damage/staining observed throughout the ceiling. The current tenant also advised the water issue has been present for 15 yrs. Although the roof structure was not fully accessible, there is a great risk of roof collapse/failure with additional snow loading and the compromised roof structure.
